How Gears Fail

By Daniel H. Herring

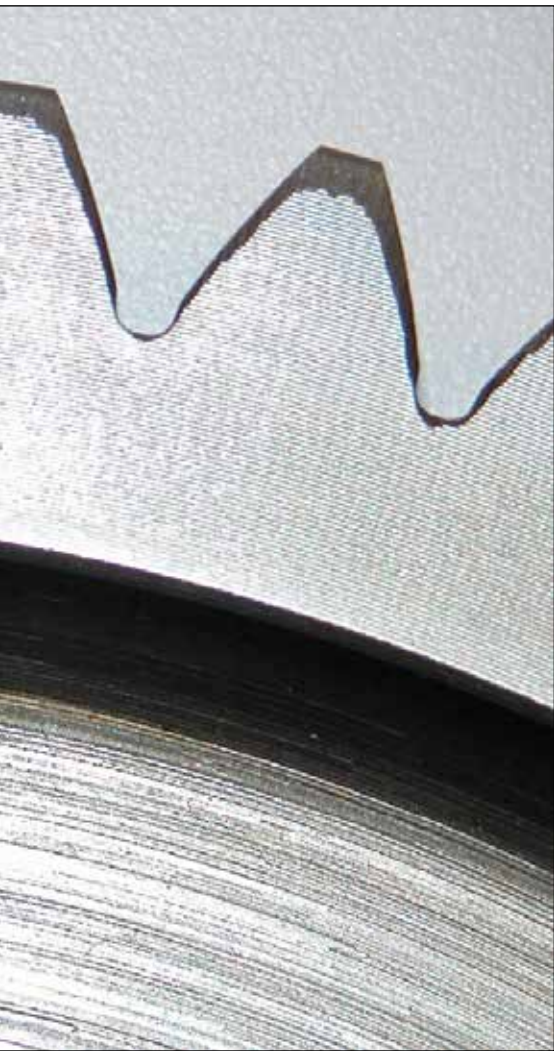
Root fillet cracks and fractured teeth failure are generally the result of cyclic bending stresses exceeding the fatigue strength of the material at the root fillet surface (Figure 1). Improper case depth, non-martensitic transformation products (NMTP) in the root microstructure, and overload conditions can cause surface cracking, followed inevitably by crack propagation to failure.

Figure 1: Tooth damage due to bending fatigue.

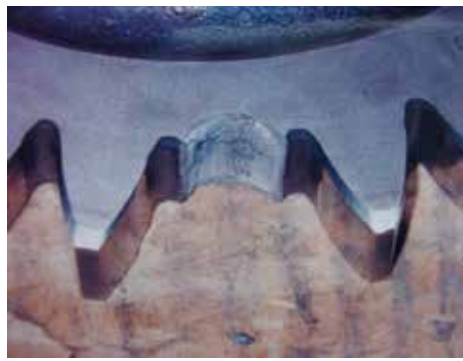
Figure 2: Gear teeth torn away from the surface of the gear.

Case crushing (Figure 2) is a related phenomenon; both can be due to improper heat treatment, a high-stress concentration, or both. Case depths that are either too shallow or too deep (not leaving an adequate core to support the case) are common heat treatment-related causes.

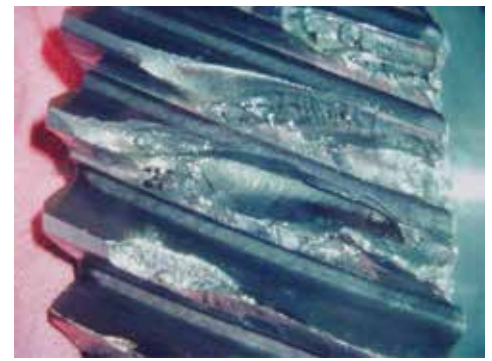
Figure 3: Severe pitting from end loading.

Surface or sub-surface pitting (Figure 3) occurs at the intersection of the applied (shear) stress and allowable strength at or extremely close to the surface. When sliding is present and the coefficient of friction is significant (due to poor lubrication, improper lubricant selection, or lubricant breakdown), the stress is maximized at the surface.

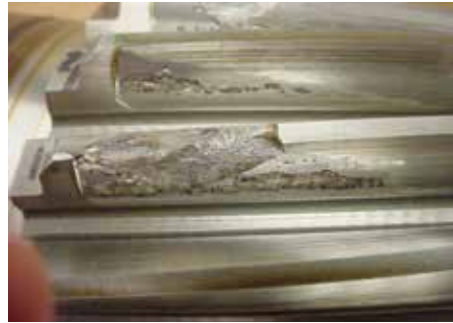
Figure 4: Soft spots in the carburized case (Observed After Shot Peening).

Other types of gear failures can be traced to poor heat treatment, such as shallow case depth or soft spots (Figure 4) from improper cleaning, incorrect case hardening

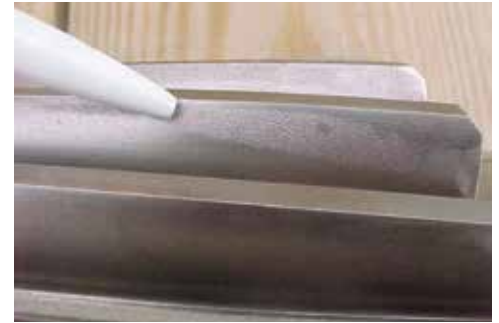
Figure 5: Inadequate hardness leading to gear failure.

process parameters, stop-off paint failures or from improper tempering. Poor quenching methods and improper austenitizing temperatures can also lead to inadequate hardness, with gears prematurely failing due

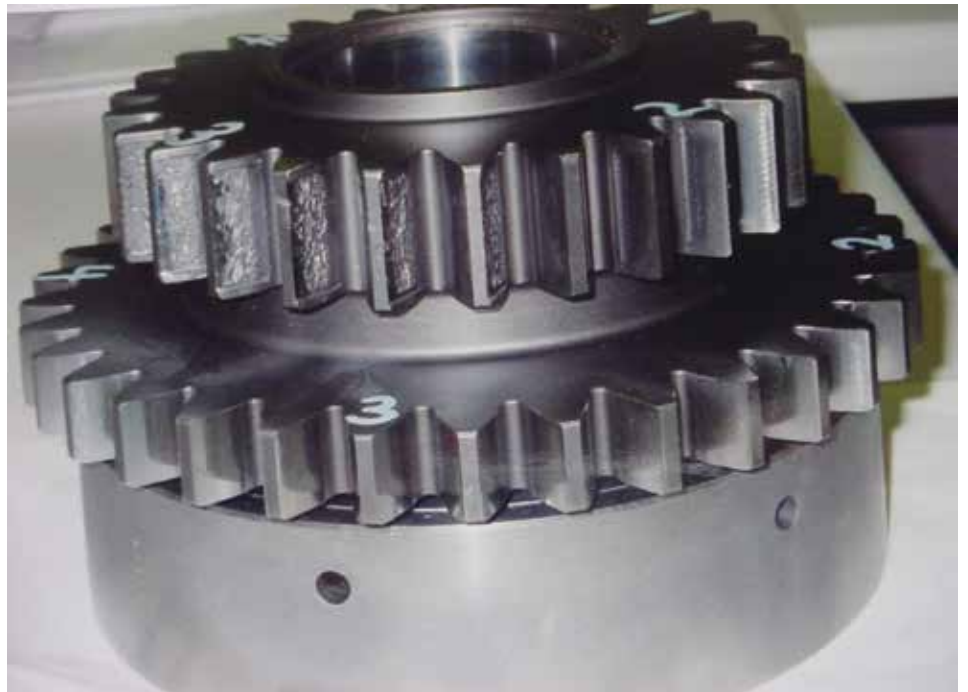
to soft teeth (Figure 5). Material issues such as hardenability, grain size, and inclusions (Figure 6) can result in various gear failures. This underscores the criticality of steel cleanliness as well as controlling the size,

Figure 6: Inclusion initiated pitting in vacuum degassed steel.

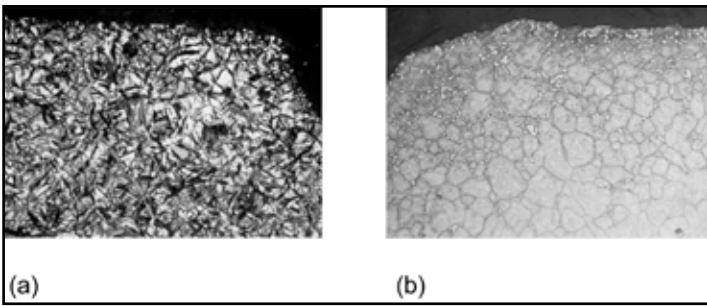
Low case hardness can also be due to carburizing with too lean a carbon potential, formation of undesirable microstructural constituents, partial decarburization of the surface, a “slack” quench, or use of the wrong tempering temperature. Variations in process parameters result in undesirable microstructures. Excessive retained austenite (Figure 8a) and excessive carbide formation (Figure 8b) both can lead to premature failure of the gears in service. Large amounts of retained austenite result from too high a carbon potential or direct quenching from carburizing temperature. Possible causes of carbides and carbide necklacing is, again, too high a carbon potential, insufficient diffusion time, too short a soak time, and too low a hardening temperature.

Figure 8: Case microstructure variation due to out of control process parameters.

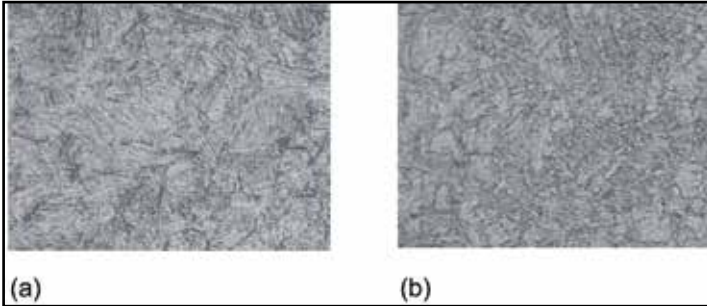
Variations in quenching, even within the same quench medium, can cause improper core microstructure and hardness. An 8822RH transmission gear was quenched at two different gas pressures (20 bar and 12 bar), resulting in differences in hardness and microstructure (Figure 9).

Figure 9: Core microstructure variation due to quenching (a) fully martensitic microstructure, 44 HRC (b) martensite with transformation products (bainite and ferrite) present, 26 HRC.

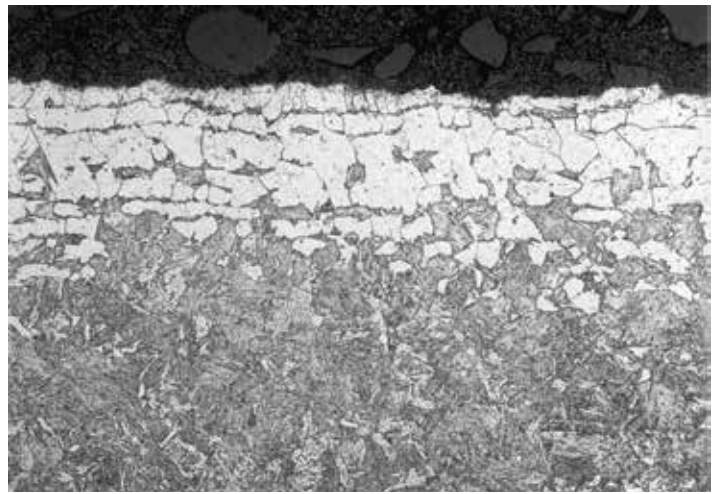
The condition of a particular heat treat furnace can also play a major role in premature gear life. Air intrusion into the furnace, whether through poor practices or leaks, can affect case hardness and residual stress patterns by creating partial or, in some extreme instances, total surface decarburization (Figure 10). Common reasons for this condition to exist are: Having an atmosphere carbon potential less than the surface carbon within the part, or a loss of protective atmosphere (e.g. when a power failure occurs).

Figure 10: Complete surface decarburization.
