**TROUBLESHOOTING AND
PREVENTION OF CRACKING IN**

INDUCTION HARDENING OF STEELS

LESSONS LEARNED – PART 2

By GARY DOYON, DR. VALERY RUDNEV, RANDALL MINNICK, and TIM BOUSSIE

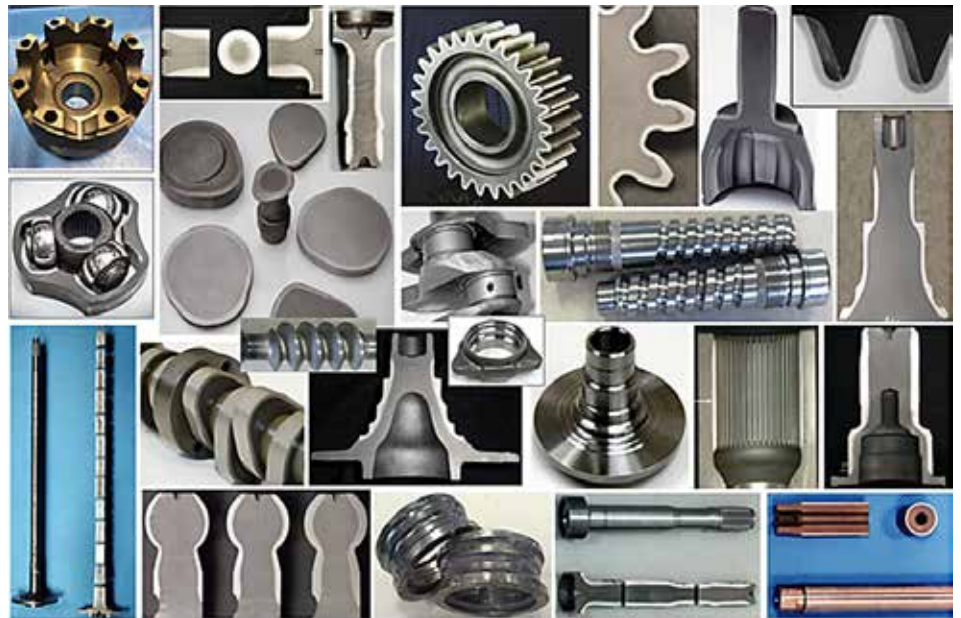
Figure 1: A small array of components that are routinely induction hardened and hardness patterns.

There are thousands of highly successful induction-hardening machines that produce millions of parts supplied to various industry segments. Among the components that routinely undergo induction hardening (IH) are such parts as camshafts, crankshafts, gears, sprockets, transmission shafts, ball studs, pins, toothed racks, wheel spindles, bearing races, fasteners, working tools, track shoes for earth-moving machines – the list is essentially endless. As an example, Figure 1 shows a small array of geometries that are routinely induction hardened.

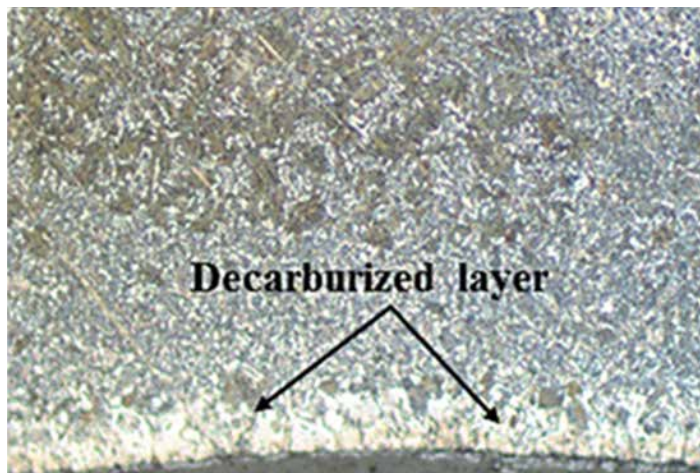
Figure 2: An example of a decarburized surface layer (light color region indicates a depletion of the surface carbon).

Decarburization indicates the loss of surface and near-surface carbon content (carbon depletion) from the steel after being exposed to sufficiently high temperatures in an oxidizing atmosphere, such as air (Figure 2). The depth of the decarburized layer is a complex function of several factors [1].

A considerable amount of decarb is commonly present when dealing with as-hot rolled bar stock, as well as as-forged, annealed, or normalized steels. The presence of decarburized layers at the surface of "green" parts exhibits a significant problem for IH since those layers will remain within the as-quenched structure, worsening strength, wear resistance, fatigue life, impact and bending properties, etc.

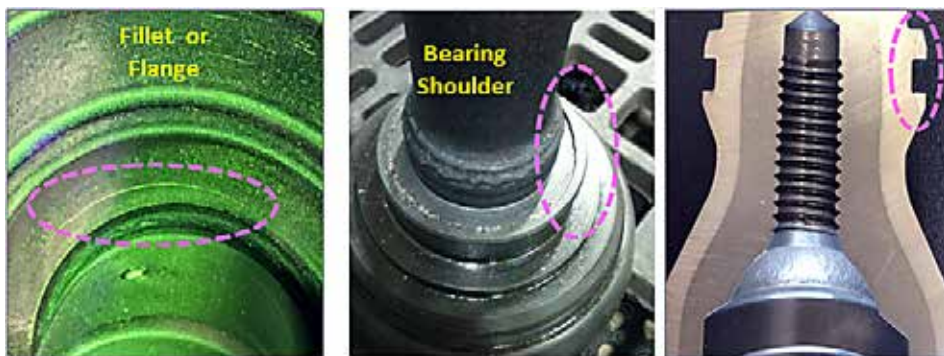
Figure 3: Typical fractures due to underestimating the eddy current flow, applying inappropriate hardening techniques, coil designs, and/or inadequate process protocols.

There are several regions of concern when hardening the flanged shafts. One such area where a circumferential surface fracture may occur is the radius (fillet) between the shaft portion and the flange (Figure 3, left). Coarser initial grains and a deeper case depth increase a probability for cracking. For example, a hot upset flange may exhibit a considerably coarser initial grain structure compared to hot-rolled bar stock of the shaft. The concern of cracking is particularly alarming in applications of through-hardened flanges or when a hardened case depth occupies a substantial portion of the flange thickness.

Another area of concern is located in the proximity to a bearing shoulder (Figure 3, center). Sharp shoulders, corners, and large diameter changes can considerably distort the eddy current flow and may produce a measurable temperature surplus forming undesirable microstructures susceptible to a crack development. Those cracks are also typically circumferential. Higher temperatures and deeper hardness case depths in that area increase the likelihood for a surface fracture.

If improperly addressed, such geometrical discontinuities such as machined grooves, slots, undercuts, keyways, snap rings, teeth, etc. can also cause cracking [1, 4, 5]. As an example, Figure 3, right, reveals some local fractures. Heat surpluses and unequal metal expansion/contraction in a combination with excessive quench severity were causes of those fractures. Improved inductor profiling, process recipe, and modified quenching can help to eliminate cracking.

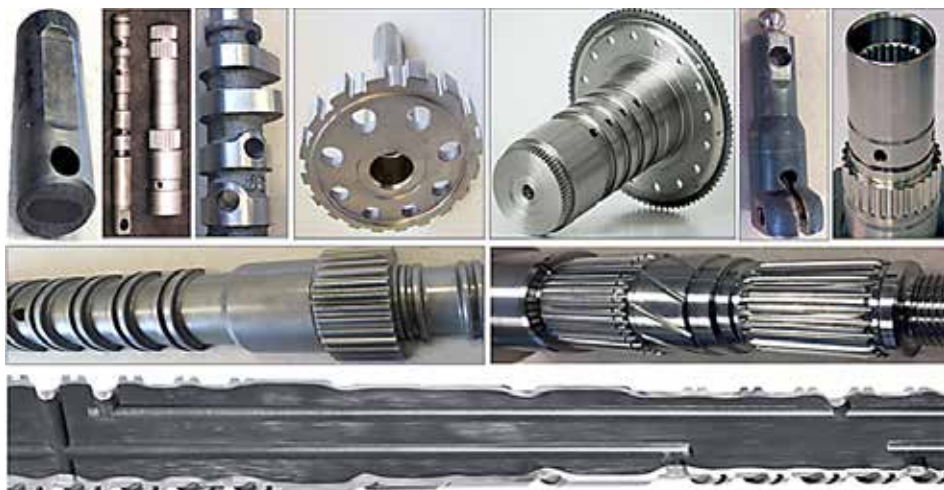
Figure 4: Examples of parts containing various holes: longitudinal (axial), transverse, and cross holes.

It is not unusual for modern shaft-like components to contain longitudinal (axial) and/or transverse holes (Figure 4) as well as angled or cross holes. Those holes result in an eddy-current flow diversion potentially resulting in an appearance of "hot" spots and, if not properly addressed, crack-initiation sites (Figure 5).

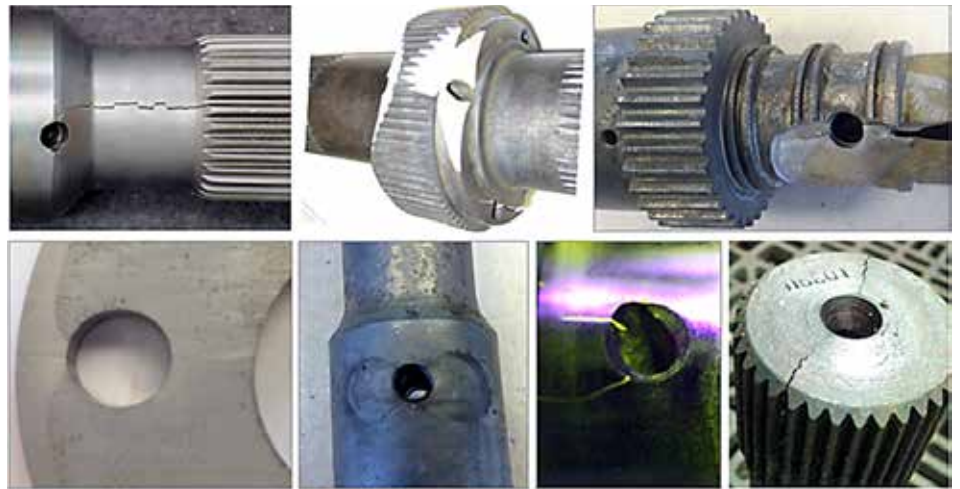
Figure 5: Examples of cracking appearing within the proximity to holes.

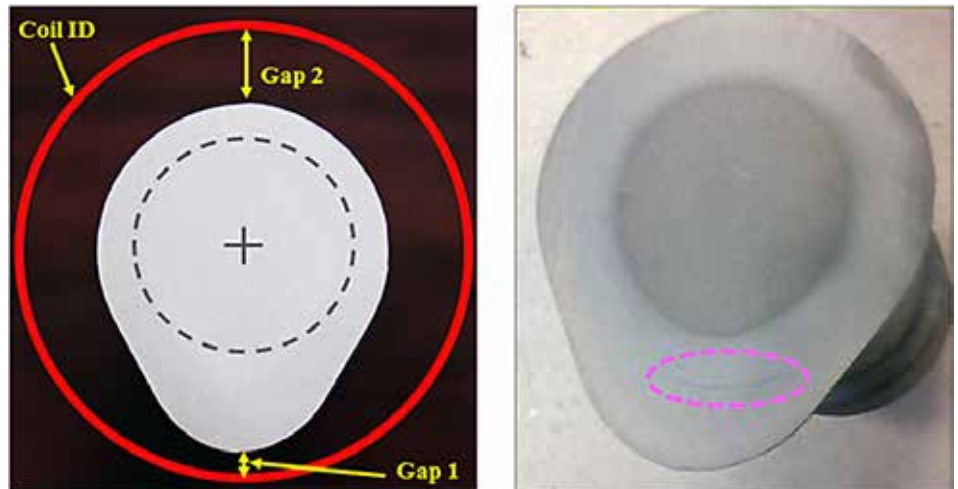
Figure 6: Variation in electromagnetic coupling between the coil inside diameter (Coil ID) and different regions of the cam lobe (left) and subsurface thumbnail cracking (right) [8].

In the past, IH of camshafts commonly require their rotation. Unfortunately, because the nose of the cam lobe has a closer electromagnetic coupling with the coil, this approach was associated with noticeably deeper case depths in the nose compared to its base circle (the heel). As an example, Figure 6, left, illustrates a typical variation in electromagnetic coupling between the coil inside diameter (coil ID) and different regions of the cam lobe. Deeper case depths are associated with reaching higher temperatures.

An attempt to provide a minimum required hardness case depth in the poorly coupled base circle/heel region may result in an overheating of the nose that could not only worsen the camshaft's characteristics including its straightness, but it can also produce an undesirable stress state, severe grain coarsening, and incipient melting, potentially causing surface or subsurface cracking (Figure 6, right). When

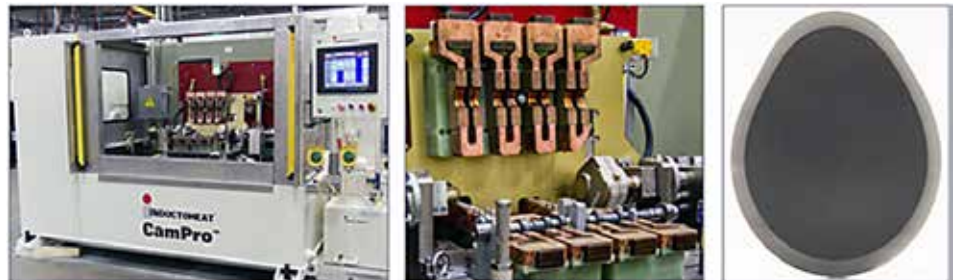
Figure 7: A CamPro® machine that uses SHarP-C™ (left), multi-lobe inductor design (center), and hardness pattern (right). (Courtesy of Inductoheat Inc., an Inductotherm Group Company)

In order to dramatically minimize a probability of cracking, a non-rotational SHarP-C™ technology has been effective for contour hardening of cam lobes. Figure 7, left, shows a CamPro® machine that uses SHarP-C™ technology, a multi-lobe inductor design (Figure 7, center), and a hardness pattern (Figure 7, right). Experience shows that a CamPro® machine can not only exhibit reduced energy consumption, but it also can produce much straighter camshafts. Some users of CamPro® machines have reported almost undetectable camshaft distortion, an elimination of the entire straightening operation, and measurable scrap reduction [8].

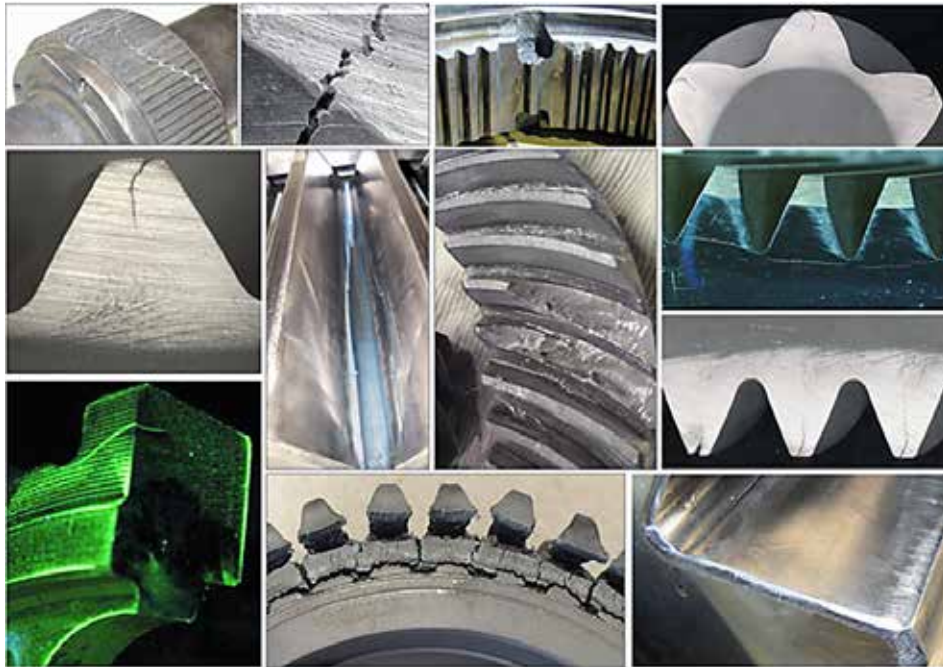
Figure 8: An appearance of cracking in the heat treating of gears and gear-like components.

Certain part geometries and materials grades might be prone for a particular failure mode. As an example, Figure 8 shows an appearance of a variety of cracks when heat treating gears and gear-like components. Even a brief look at Figure 8 reveals a complexity of factors, an ambiguous nature of cracking and its root cause(s)
