How Gears Fail

By Daniel H. Herring

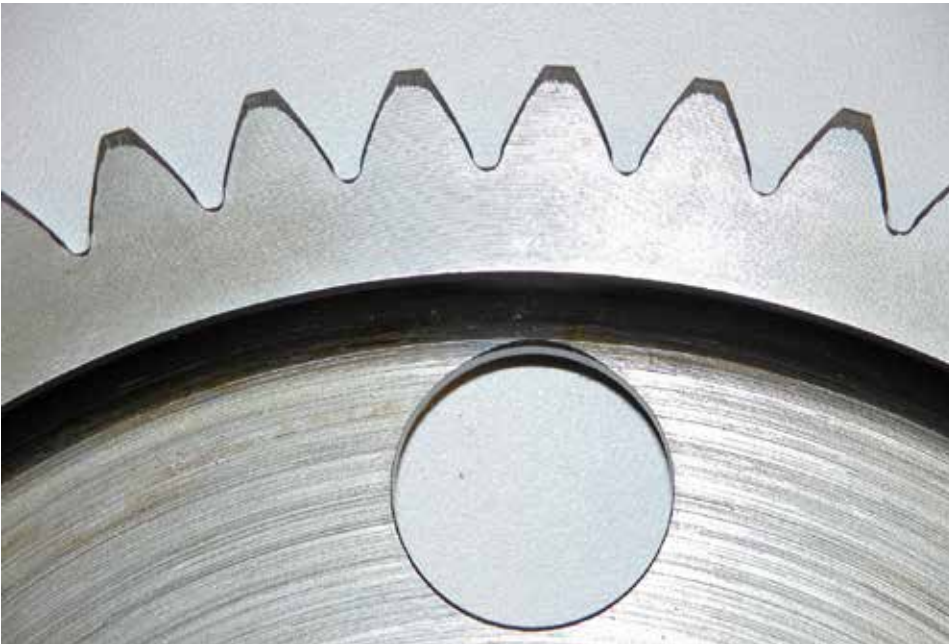
Figure 7: Improper hole placement.

toughness), and by design (Figure 7) and manufacture (residual compressive stress state, surface finish, and geometry). The objective of heat treatment is to have high hardness and adequate subsurface strength on the active flank and good surface hardness and high residual compressive stress in the root area.
