Blistering of aluminum during heat treatment

In this column, we will discuss the blistering of aluminum during heat treatment, and methods to prevent its occurrence.

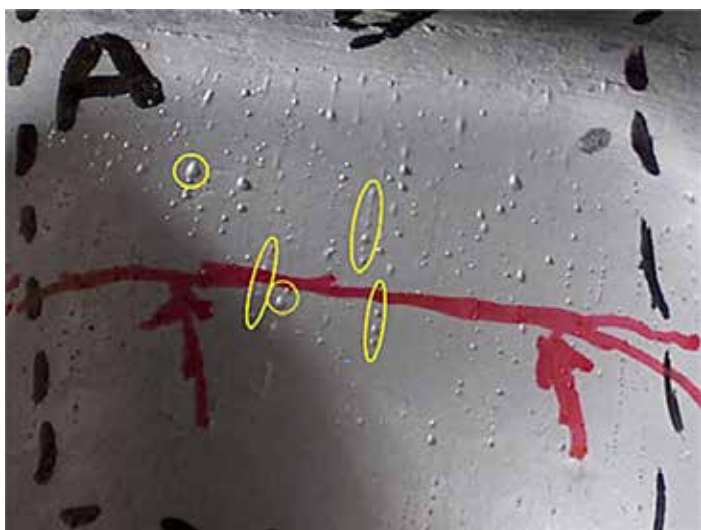
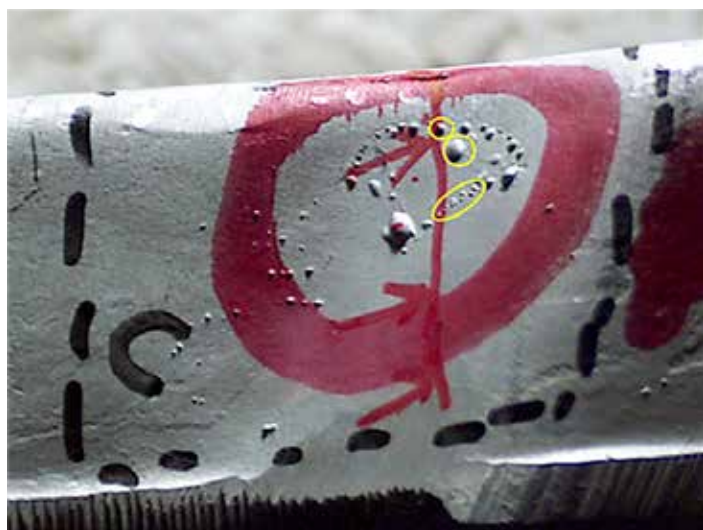
Figure 1: Appearance of blistering on 7075 forging.

High-temperature oxidation, or blistering, often occurs in heat treated aluminum alloys. High-temperature oxidation is a misnamed condition of hydrogen diffusion that affects surface layers during elevated-temperature treatment. This condition can result from moisture contamination in the furnace atmosphere and is sometimes aggravated by sulfur (as in heat-treatment furnaces also used for magnesium alloy castings) or other furnace refractory contamination. The visual appearance of blistering is shown in Figure 1.
