Process Evaluations Can Help Narrow Down the Causes of NMTP Formations that Can Reduce Component Performance.

By Lee M. Rothleutner

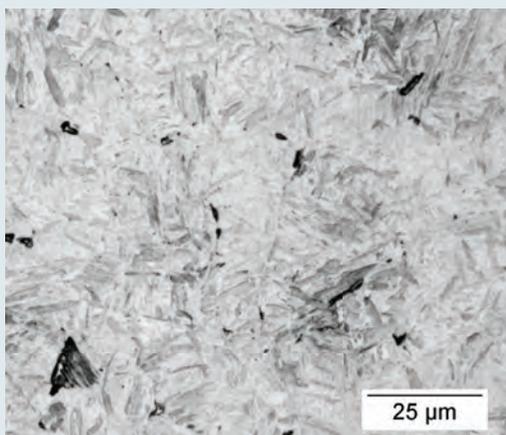
Figure 1: Optical micrograph of a region within the induction-hardened case of a 1045 shaft showing NMTP as dark etching features [1]

Figure 1 shows an optical micrograph of a 1045 steel in a region of an induction-hardened case that was intended to be fully martensitic. The dark etching features are readily identifiable as non-martensitic constituents; however, not all are easily identified as NMTP. Understanding the processing used to generate the microstructure and/or higher magnification imaging are usually required to distinguish between retained and transformed non-martensitic constituents. Figure 2 shows a

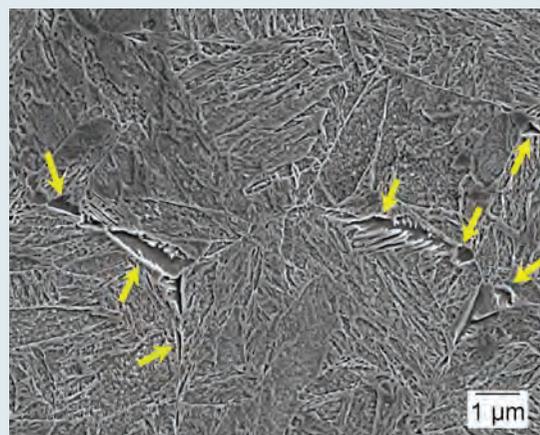
Figure 2: Scanning electron microscope secondary electron image of NMTP identified by arrows [1]

higher magnification secondary electron image of a region adjacent to the micrograph shown in Figure 1. Arrows indicate the microstructural features in question. Based on the sharp ferrite morphology and carbide precipitation behavior, the constituents appear to have formed upon cooling, confirming their designation as NMTP.

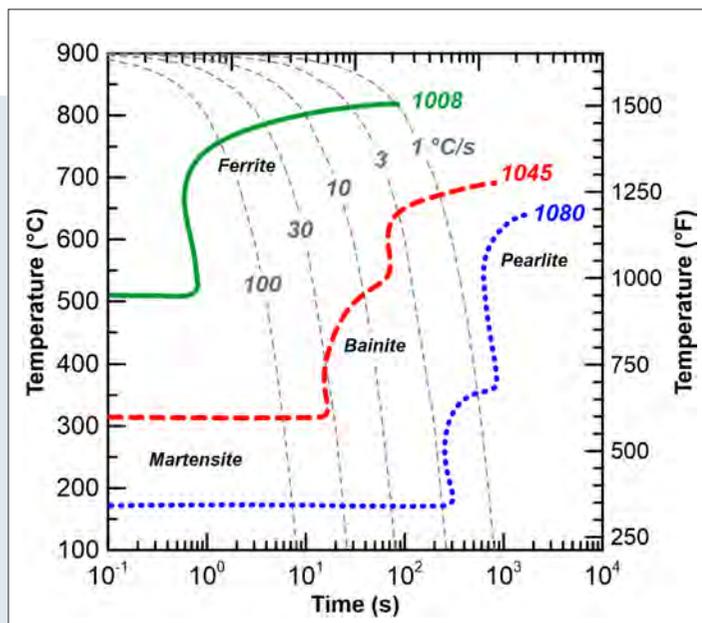
Figure 3: Continuous cooling transformation diagrams for 1008, 1045, and 1080 plain carbon steels, indicating the initiation of austenite decomposition into different phases and constituents (in this case, 1-percent transformed). A range of cooling rates is shown for reference. Developed using data from EWI [3]

Although many of the scenarios that can result in NMTP are listed here, a conceptual understanding of the factors controlling NMTP formation is often more useful when actively troubleshooting a process. Figure 3 shows continuous cooling transformation (CCT) diagrams for three plain carbon steels: 1008, 1045, and 1080. For the sake of simplicity, only the 1-percent transformed locus for each phase or constituent is shown. This figure clearly shows the relationship between carbon composition and transformation behavior for a given cooling rate. As carbon content increases, transformation temperatures decrease, as does the cooling rate required to achieve a specific microstructure.

For example, one hypothesized scenario in which this figure is useful is under-heated 1045 steel (“under-heated” meaning insufficient temperature or too little time at temperature during austenitization). In this case, it is unlikely that all the carbon will go into solid solution, resulting in regions that may exhibit transformation behavior analogous to steels of lower carbon composition and shift the CCT to slightly higher temperatures and shorter times (more toward a 1008 steel). Consequently, a higher cooling rate is required to achieve a fully martensitic microstructure.

Figure 3 also shows the importance of cooling rate control. For both the 1045 and 1080 steels, the bainite “nose” has a nearly vertical region where the cooling rates are close to the critical cooling rate (i.e., the minimum cooling rate required to create a fully martensitic microstructure). This behavior indicates that these steels can exhibit significant amounts of NMTP with only minimal reduction in cooling rate.
