# **Ensuring Effective Furnace Lining Efficiency**

These five tips can help you maximize energy efficiency and minimize heat loss with effective insulation and furnace lining solutions.

By Steve Chernack

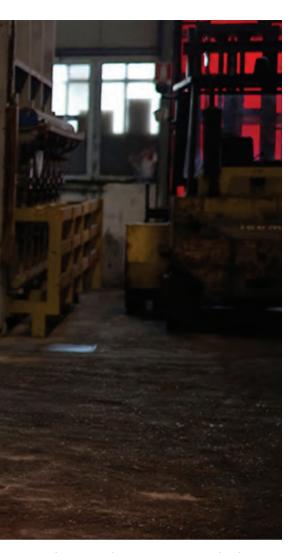
In order to identify hot spots where the unit is leaking or reducing performance, infrared

thermography scans are essential. This typically involves pointing an infrared camera at several points on the furnace casing to analyze the external temperature and identify any areas where heat loss is occurring. Although these can be conducted from within the furnace, such scans are more effective when performed from the outside, because this enables engineers to keep the furnace in operation. It is advised that specially trained application engineers carry out any infrared imaging, analyze the scans, and provide recommendations on the most appropriate repair options.
