Cures for Heat Treaters' Headaches

By Curt Colopy

A discussion of what causes furnace component failure and the commercially available improvements or substitutes.

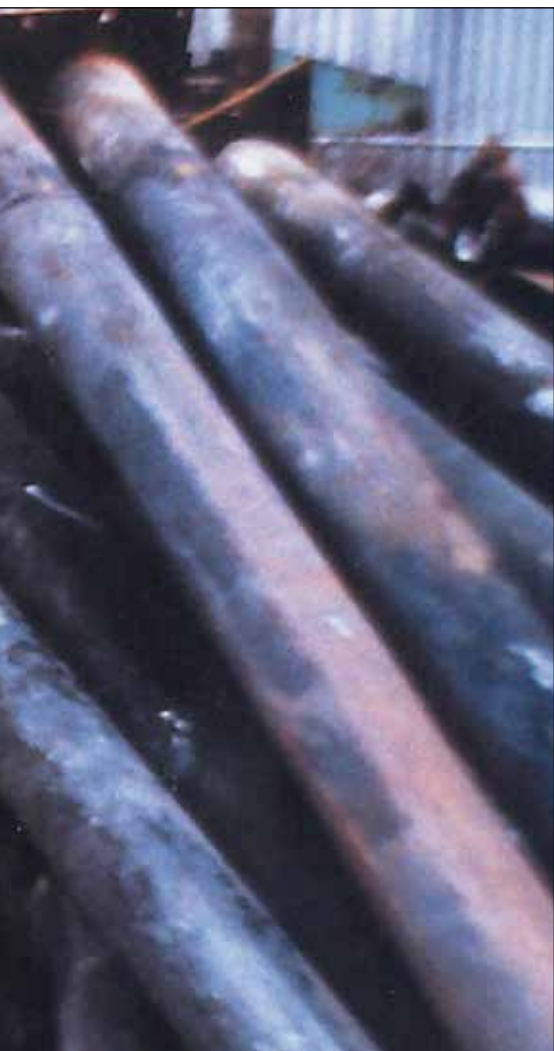
Fig 1: Expensive alloys can creep, distort, and rupture in a short time.

Fig 1 dramatically shows what we typically deal with: relatively short service life and corresponding high life-cycle cost of expensive alloys that creep, distort, and rupture in just a year or two. Staring at this scrap pile a feeling of hopelessness engulfs us and real improvement seems impossible; often we just install another tube or tray or belt and move on. The famous remark attributed to Albert Einstein comes to mind: “Insanity is doing the same thing over and over again, and expecting different results.” Are there superior alloys, or alternative materials such as composites and ceramics that may perform even better than metals, available to improve both lifetime and life cycle cost?

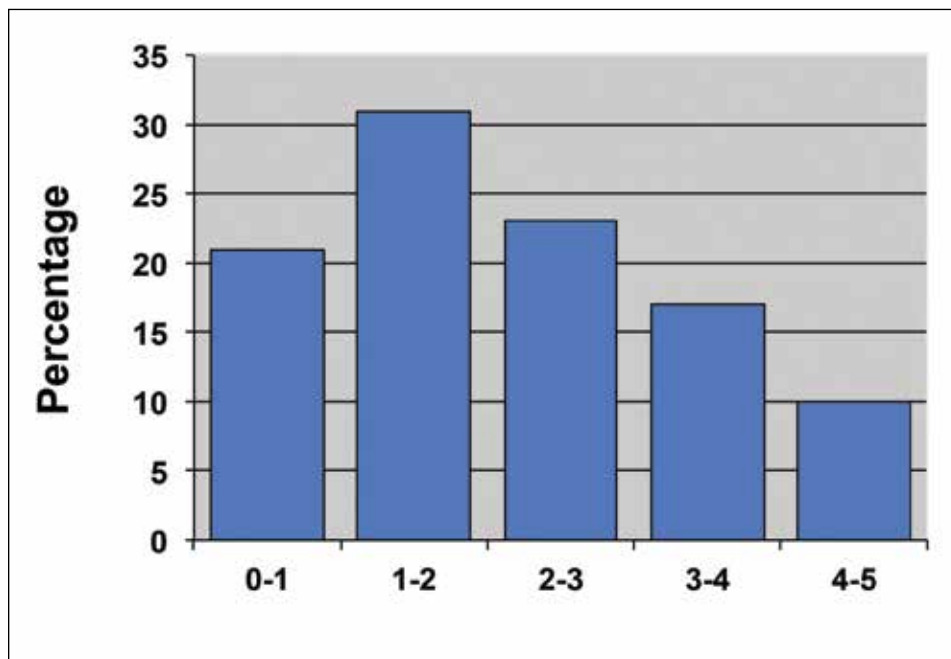
Fig 2: GRI study of alloy tube life.

Fig 2 presents a service-life survey of all types of radiant tubes conducted by the Gas Research Institute in the mid 1990s (the most recent data available). This survey did not differentiate between radiant tubes used for carburizing and those used in less aggressive heat treating processes or mixed service. The tubes lasting up to two or three years were probably carburizing for a large percentage of the time. Those with life over three years likely saw lower temperature operation and more neutral atmospheres in service. Unfortunately, similar data is not available for other furnace components.

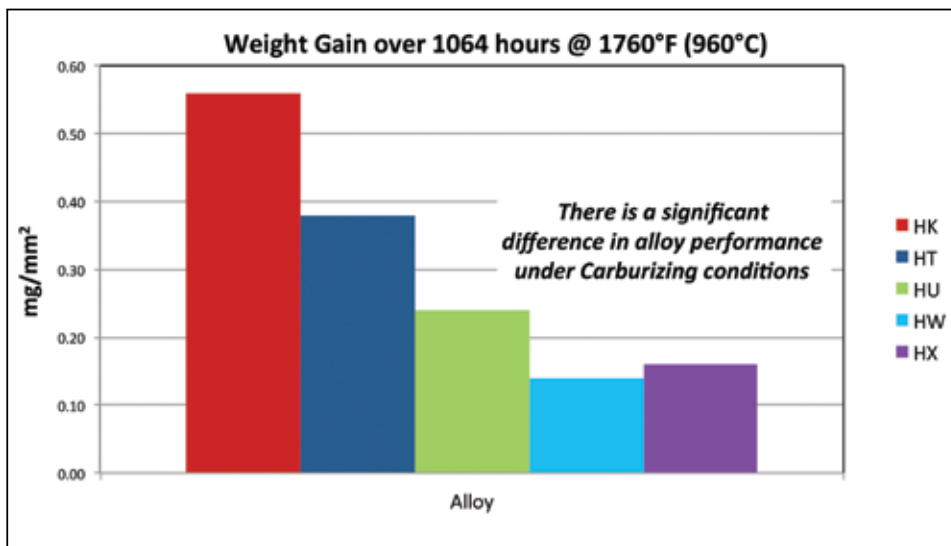
Fig 4: Carburization resistance.

Fig 4 presents the carburization resistance of five common cast alloys: HK, HT, HU, HW and HX. Their performance differs greatly by a factor of four,

from best case HW to worst case HK, as indicated by their weight gain over 1,064 hours at 1760°F (960°C). Generally the tendency to carburize is decreasing from the left side of graph towards the right as the nickel content of the alloy increases. While the test temperature is reflective of actual carburizing process conditions at many heat treat facilities, keep in mind the radiant tubes actually operate at a significantly higher temperature, and for considerably longer service than 1,064 hours (1½ months).

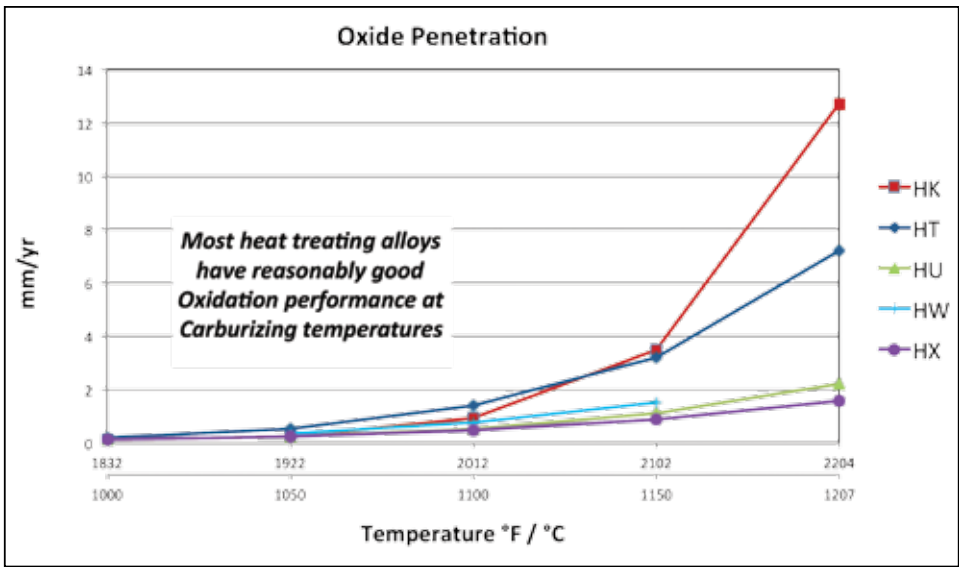
Fig 5: Oxidation resistance.

Excess combustion air as a source of oxidation inside radiant tubes was described earlier. Practically speaking, air also enters the furnace load chamber from a variety of sources including leaky seals or curtains, when the door opens to exchange loads and during weekend burnout of carbon build-up. This chamber-side oxidation also contributes to furnace alloy deterioration. However, Fig 5 shows the Oxidation Resistance of the same five cast alloys differs relatively little as indicated by surface penetration (in mm/year) of air exposure at 1832°F (1000°C).

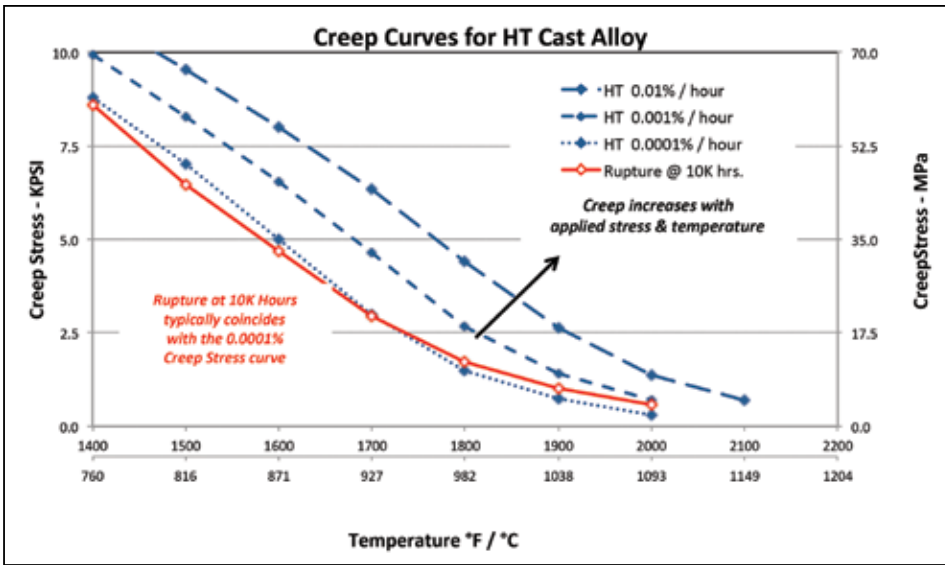
Fig 6: Interpretation of creep curves.

Fig 6 provides an introduction to creep performance for metal alloys using cast HT as an example. The three dark, dashed curves show the mechanical stress in KPSI (or MPa on the right-hand axis) required to deform an alloy sample 0.01% in one hour, 0.001% in one hour and 0.0001% in one hour as plotted from the top-down respectively. These short-term deformation curves clearly demonstrate how the combination of applied stress and temperature affect the degree of creep. The solid curve is a long-term

test showing the stress and temperature required to actually rupture a sample at 10,000 hours (1.14 years of continuous duty). Note how the solid 10,000-hour rupture curve roughly corresponds to the dashed short-term deformation curve for 0.0001% per hour. Rupture occurrence

at 10,000 hours X 0.0001%/hr corresponds to about 1% total deformation at catastrophic failure, typical for ductile metals. In heat treating, mechanical stress is supplied by the parts loaded in the tray or fixture, along with weight of the tray, fixture or radiant tube itself.

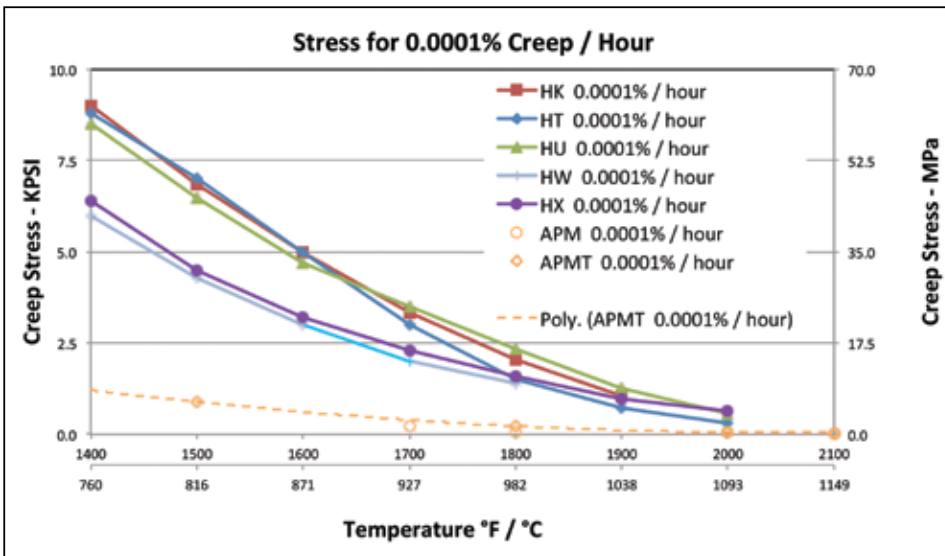
Fig 7: Cast alloy creep performance.

Fig 7 compares the creep performance for the all five cast alloys at 0.0001% per hour. At 1800°F (982°C) and above, HT, HW, and HX all have similarly low resistance to creep, with HW and HX having better carburization performance (per Fig 4). Both HK and HU have somewhat greater resistance to creep stress at 1800°F; however, HK is the most susceptible to carburization. While APM and APMT alloys have excellent high temperature corrosion resistance, their creep performance is relatively poor in this temperature regime. This alloy manufacturer recommends intermediate supports for horizontally-mounted APM and APMT radiant tubes longer than 48 inches (1.2 meters).

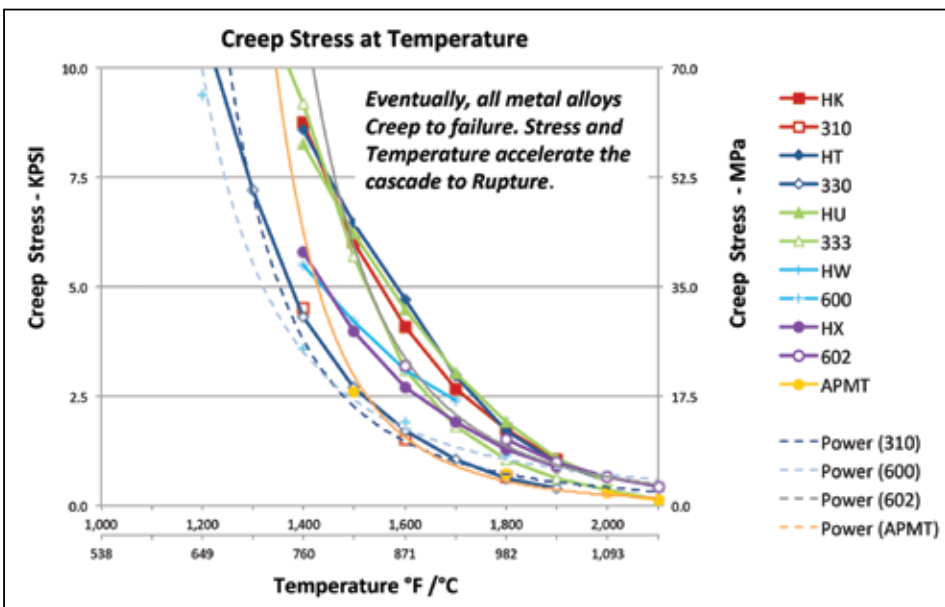
Fig 8: Alloy stress to rupture at 10,000 hours.

Fig 8 presents alloy creep curves for actual rupture at 10,000 hours (1.14 years). This chart shows that all metal alloys eventually fail above 1800° F (982°C) at relatively low levels of applied stress. Fig 9 enlarges the lower right corner for a more detailed view. At 1832°F (1000°C) the maximum stress at rupture is about 1,600 PSI (11 MPa) for all metal alloys typically used in heat-treating. This is an appropriate temperature for alloy selection when designing trays and fixtures for carburizing service. For radiant tubes operating at 2032°F (1110° C) these same alloys rupture at below 700 PSI (5 MPa). This approaches the stress induced in a metal radiant tube by simply supporting its own weight when horizontally-mounted at each end. Note this is the manufacturer's data for new alloys as-supplied—not welded, not carburized, and not thermally-cycled.

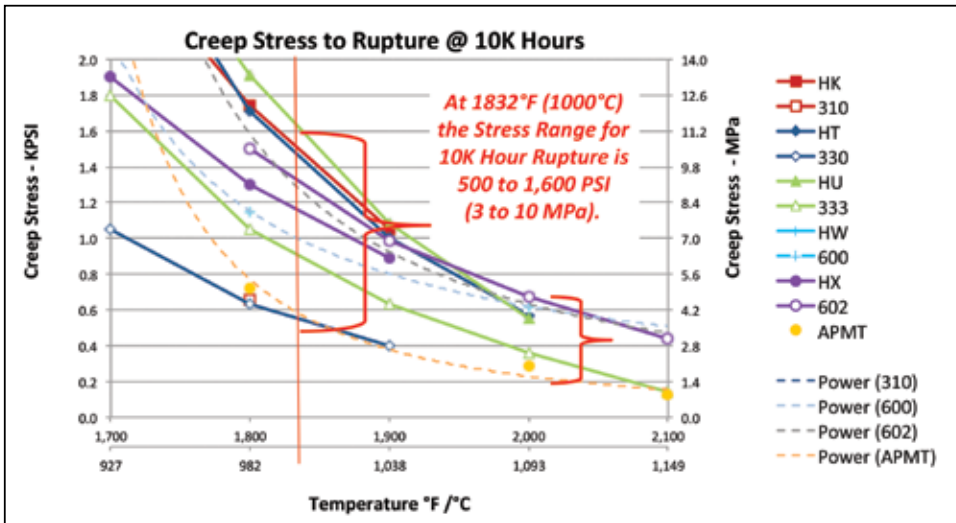
Fig 9: Alloy rupture stress range.

ed, the unloaded stress increases with length, and decreases with larger tube OD. At a middle length of 72 inches (1.8 meters) the stresses range from 105 to 255 PSI (0.7 to 1.8 MPa) depending on diameter. This is only one third the tolerable stresses for the new alloys shown in Fig 9—not much of a safety margin against a lifetime subject to the thermal and corrosive severity of carburizing conditions. Sizes for size, Si-SiC composite tubes are subject to much lower stress and have a negligible creep rate.

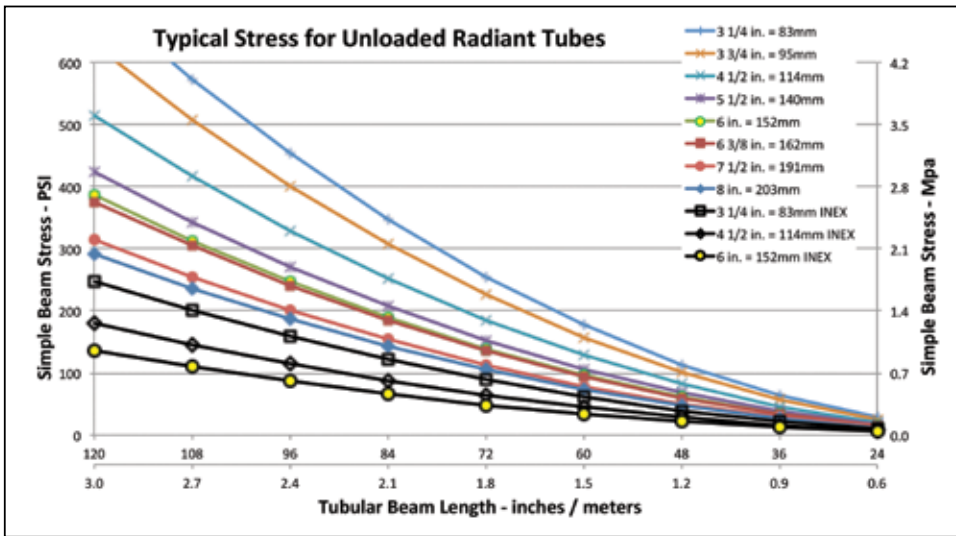
Fig 11: Structural creep stress.

Fig 11 shows the calculated structural stresses for various unloaded, horizontal tubular beams simply supported at both ends. These are induced stress plots for horizontal radiant tubes due to their own weight. The lower black lines are for three standard size Si-SiC composite tubes, which weigh only 1/3 that of comparable metal tubes, and are therefore subject to far less stress. The upper lines are standard alloy tube sizes proceeding top-down from smaller to larger diameter. Tube lengths ranging from 120 to 24 inches (3.0 to 0.6 meters) are shown left to right on the horizontal axis. As expect-

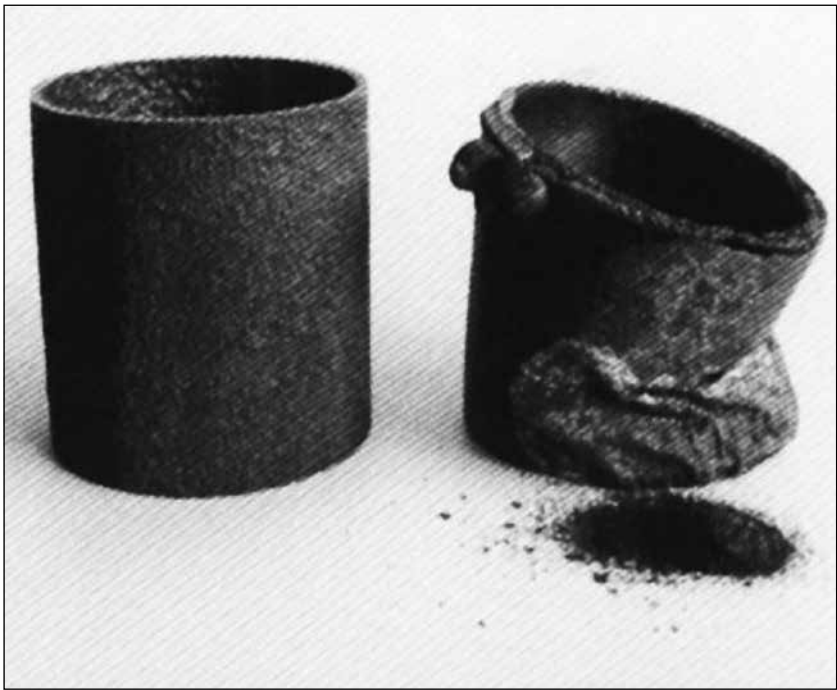
Fig 10: Si-SiC composite vs. 600 alloy (after one hour).

Fig 10 provides photographic creep evidence from an unconventional perspective comparing Si-SiC composite with high-nickel 600 alloy. The 600 tube at the right is pictured after just one hour at 2462°F (1350° C), while the Si-SiC composite tube on the left is shown after 360 hours under the same conditions. At this extreme temperature no creep deformation, distortion or rupture is observed for the INEX tube.
